**PRESERVATION PLANS FOR LIMESTONE REVETMENT
PROMONTORY POINT
54th TO 57th STREETS (EXTENDED) AND LAKE MICHIGAN SHORE
CHICAGO, ILLINOIS**

prepared for the
Hyde Park Historical Society
under the direction of the
Executive Committee of the Community Task Force
for Promontory Point

by
Cyril Galvin, Coastal Engineer
Box 623, Springfield Virginia 22150, USA
703-569-9187
galvincoastal@juno.com

1 October 2002
Copy Edited Version

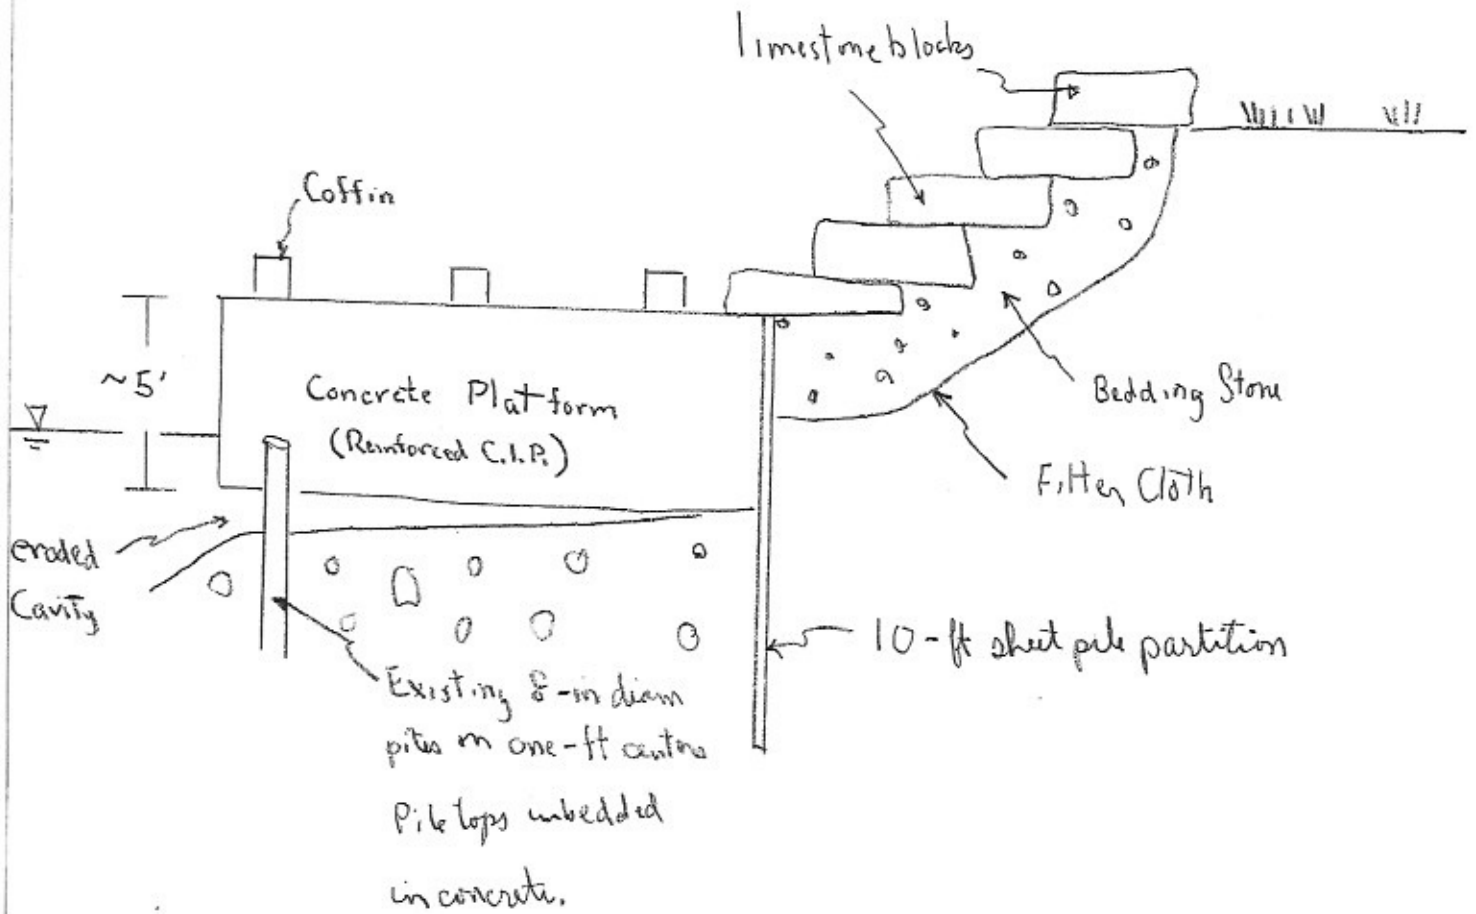
CROSS-SECTION OF EXISTING CONCRETE PLATFORM AND LIMESTONE REVETMENT

Locally, waves have damaged the shore near the northeast corner of the Point and repairs have been made in the form of the concrete platform around the most exposed segment of the perimeter. The concrete platform now needs further repair. The segment of the perimeter stepped stone revetment on the south shore of the Point is in remarkably good shape for a 65-year old structure along the Lake Michigan shore.

(Typical of the most exposed segment of perimeter)

Table 2. RENOVATION TASKS AT CONCRETE PLATFORM

1. Prepare three portable truss bridges sufficiently high to clear coffins, and sufficiently strong to support truck-mounted crane. Each bridge 20 feet long.
2. With crane, lift limestone blocks and set on grass upland. May require freeing grout.
3. Inventory reusable blocks as work progresses.
4. Grout cavities under concrete platform, with special effort to seal landward end of platform against water percolation. Caulk expansion joints.
5. Dig trench at landward side of concrete platform. Backfill with sand. Drive steel sheet as partition to eliminate undermining.
6. Prepare bedding stone landward of sheet pile. Include filter cloth.
7. Replace limestone blocks in five tiers.
8. Patch concrete on coffins and elsewhere as needed.

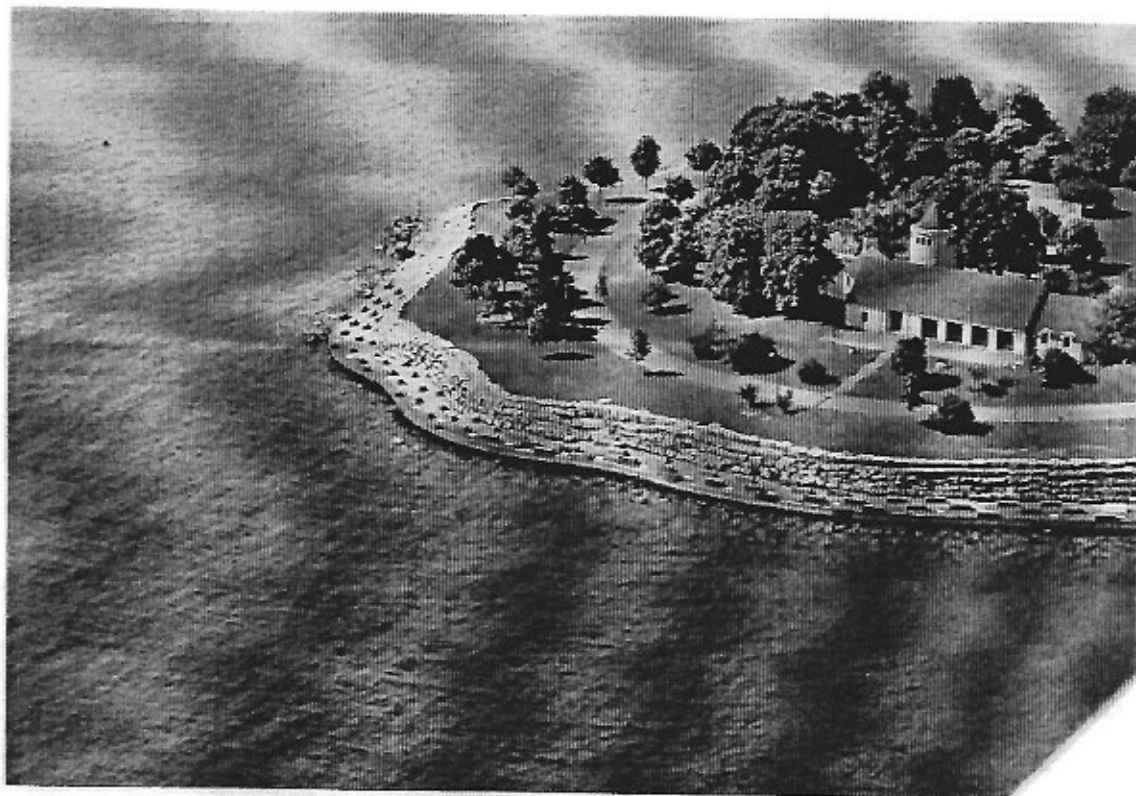
Frame A4
Roll 962

Plate 5. Both photos illustrate the concrete blocks on the Promenade, and areas of partial failure of the stepped-stone revetment (picked out by shadows).
Frame A4, Roll 962: Concrete blocks on Promenade along northeast sector of the Point shoreline. The white-painted block on the right edge of this photo is a benchmark that also appears on Plates 2, 4, and 6.
Frame A2, Roll 962: Outer (east) shore at the Point with Council Rings.

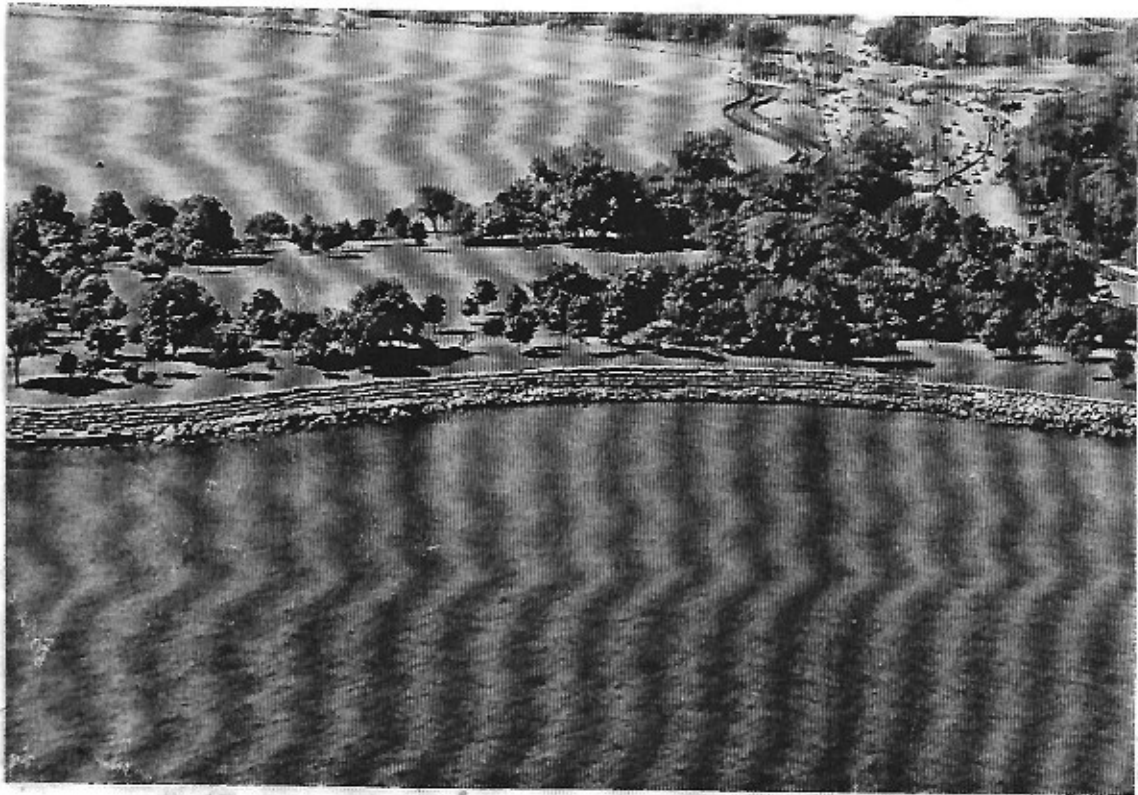
Frame A5
Roll 962

Plate 6. Both photos illustrate the stepped construction of the stone revetment which is a characteristic of the Point. The stone revetment has a fifth tier along the more exposed sector of the shore that ends at the left sides of both photos.
Frame A5, Roll 962: Stepped revetment along north shore.
Frame A3, Roll 962: Northeast sector of the shore at the Point. Promenade with concrete blocks (on left) could be the 1964 project mentioned in documents(?). Blocks visible underwater provide valuable protection against waves acting on the stepped-stone revetment.
