**PRESERVATION PLANS FOR LIMESTONE REVETMENT
PROMONTORY POINT
54th TO 57th STREETS (EXTENDED) AND LAKE MICHIGAN SHORE
CHICAGO, ILLINOIS**

prepared for the
Hyde Park Historical Society
under the direction of the
Executive Committee of the Community Task Force
for Promontory Point

by
Cyril Galvin, Coastal Engineer
Box 623, Springfield Virginia 22150, USA
703-569-9187
galvincoastal@juno.com

1 October 2002
Copy Edited Version

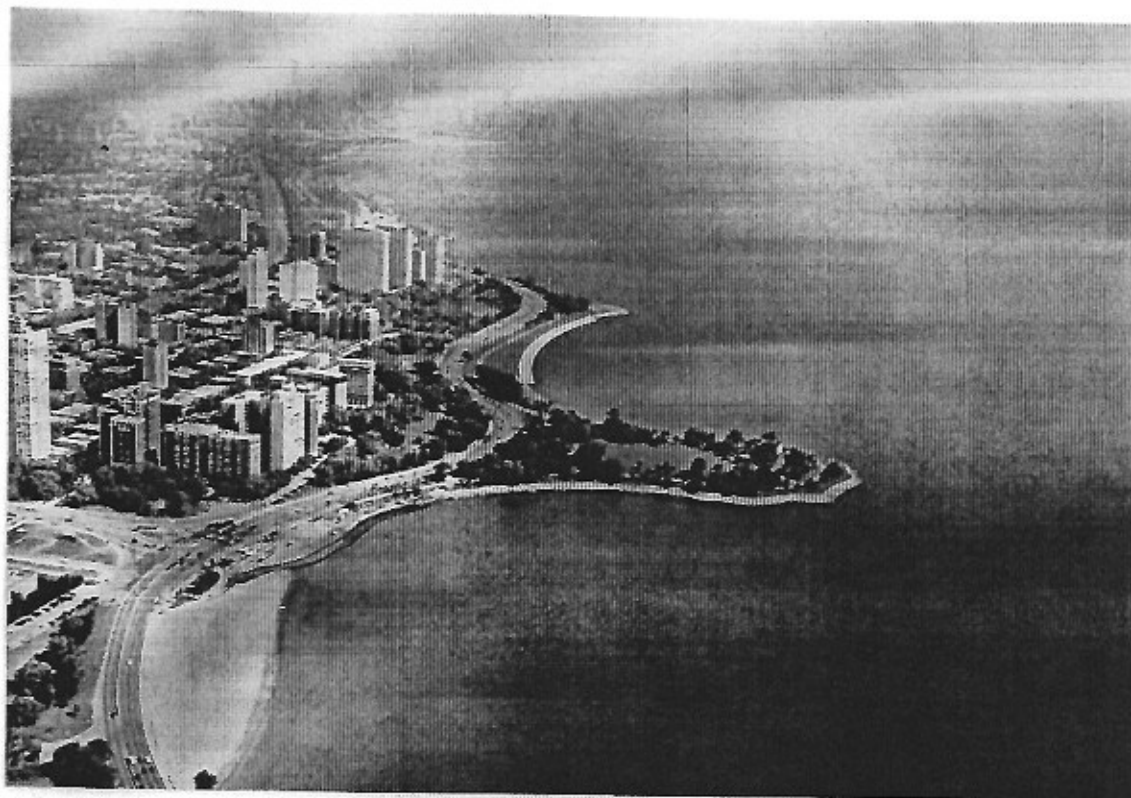
Frame 14
Roll 960

Plate 1. Both photos looking north over the Point, with underpass construction and 57th Street Beach in foreground.
Frame 14, Roll 960: Chicago skyline on horizon
Frame 15, Roll 960: View parallel to mean shoreline.

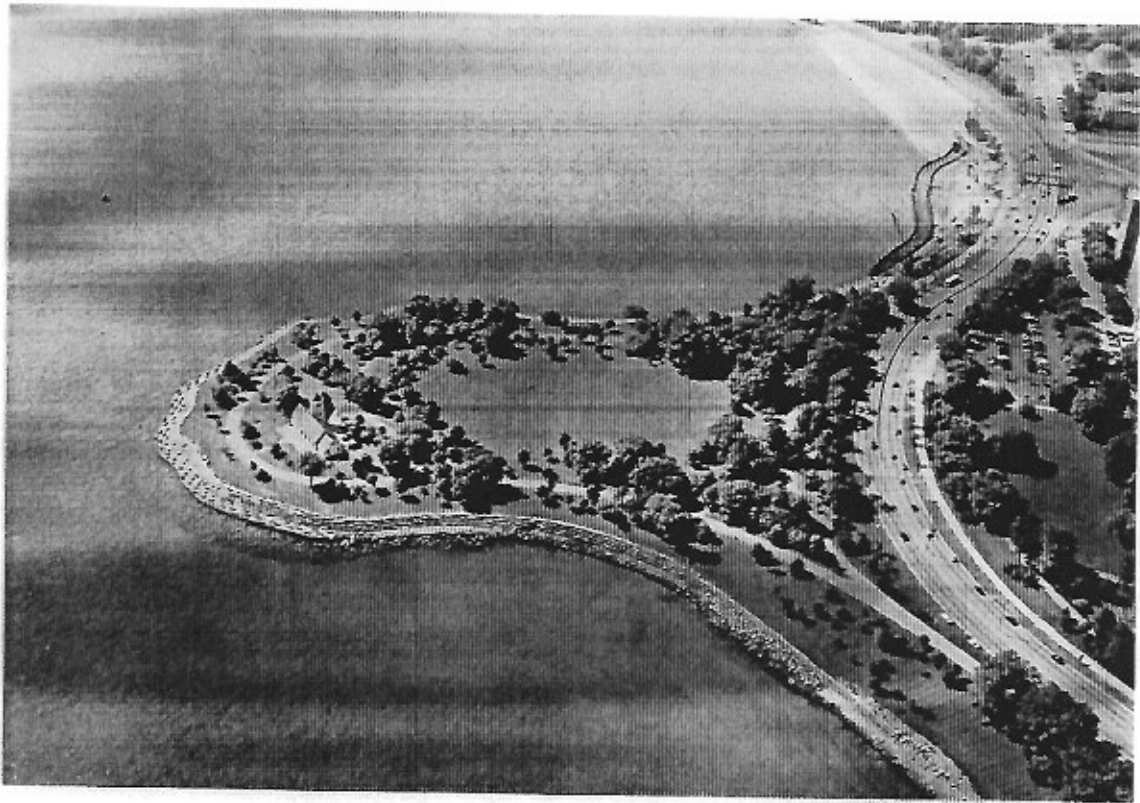
Plate 2. Frame 20, Roll 960: Look south at the Point, emphasizing the entire north shore of the Point.

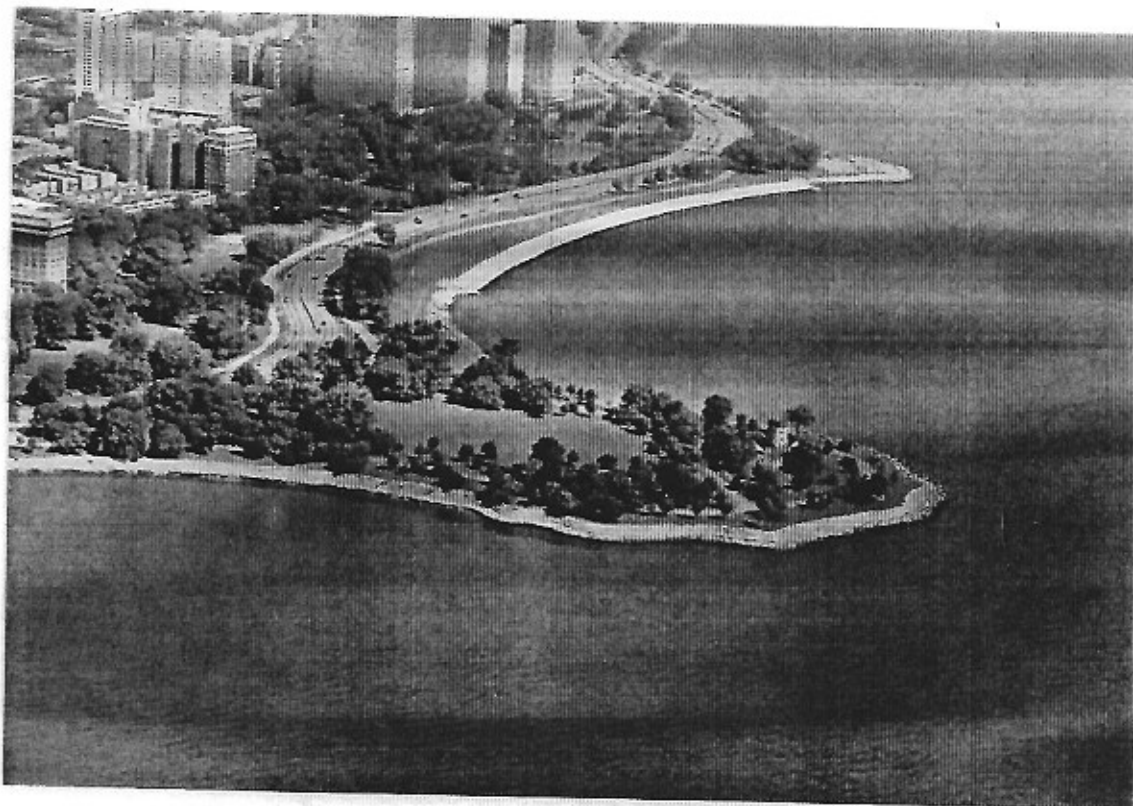
Frame A19
Roll 962

Plate 3. Both photos contrast the new shore protection (white) with the historic shore protection at the Point.
Frame A19, Roll 962: View to northwest with south shore of the Point in center; new shore protection at top of photo.
Frame 21, Roll 960: View to south with new construction in center. Holding yard (?) for stone block in foreground

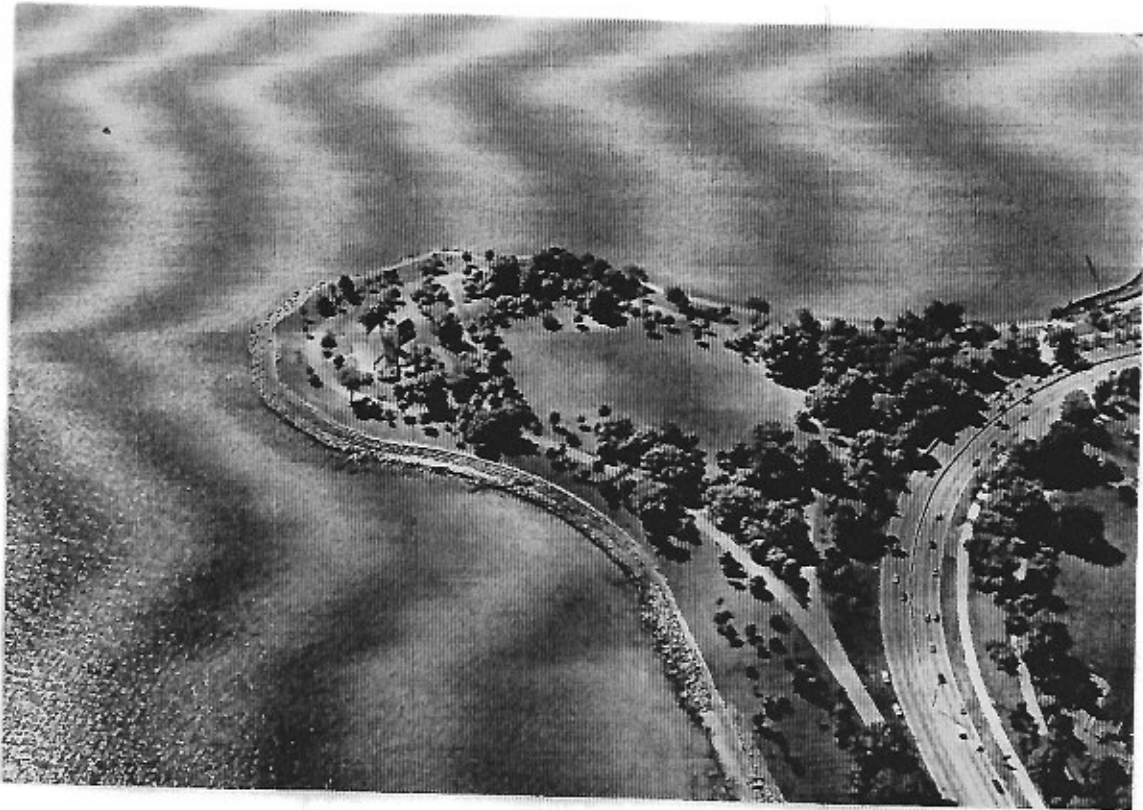
Frame 19
Roll 960

Plate 4. Two views of the Point as a whole.
Frame 19, Roll 960: View of entire Point, looking south. Lake Shore Drive on the right marks landward boundary of the Point.
Frame A7, Roll 962: View looking landward from over the Lake: south shore on left; east shore in foreground; north shore on right.
