Report of the Promontory Point Mediator

This report was prepared at the request of Alderman Leslie Hairston and commissioned by the South East Chicago Commission. Its purpose is to provide an independent review of the feasibility of a "preservation" design for the restoration of Promontory Point.

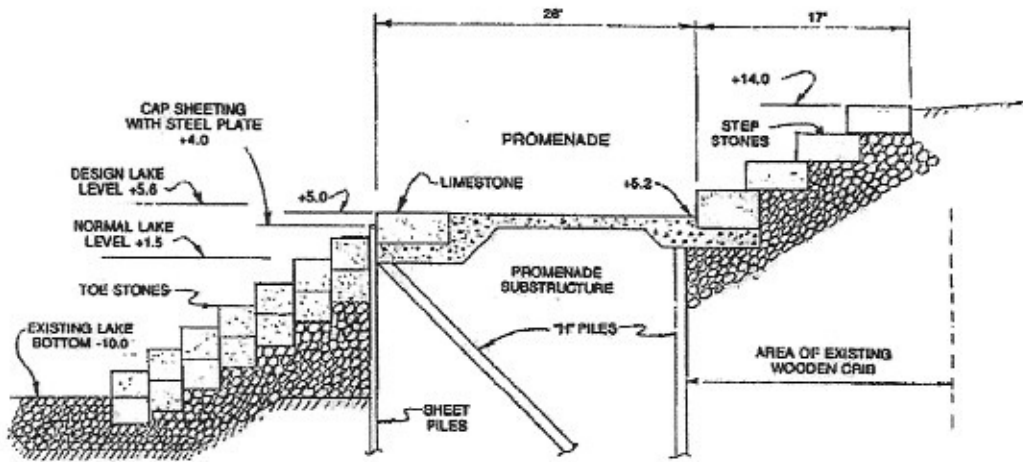
Scale: 1/8" = 1'-0"

They differ in one minor respect. The Figure 1 design replaces the shear key in the City design with additional batter pile. [See Figure 2.] This modification is a different way of performing the same function at the same level of structural performance.

Option 3 most closely resembles the step stone configuration in the design under review in that all the revetment steps are of limestone. [See Figure 4.] It differs from the Figure 1 design in that it has five rather than four steps and makes use of ten rather than four stones.

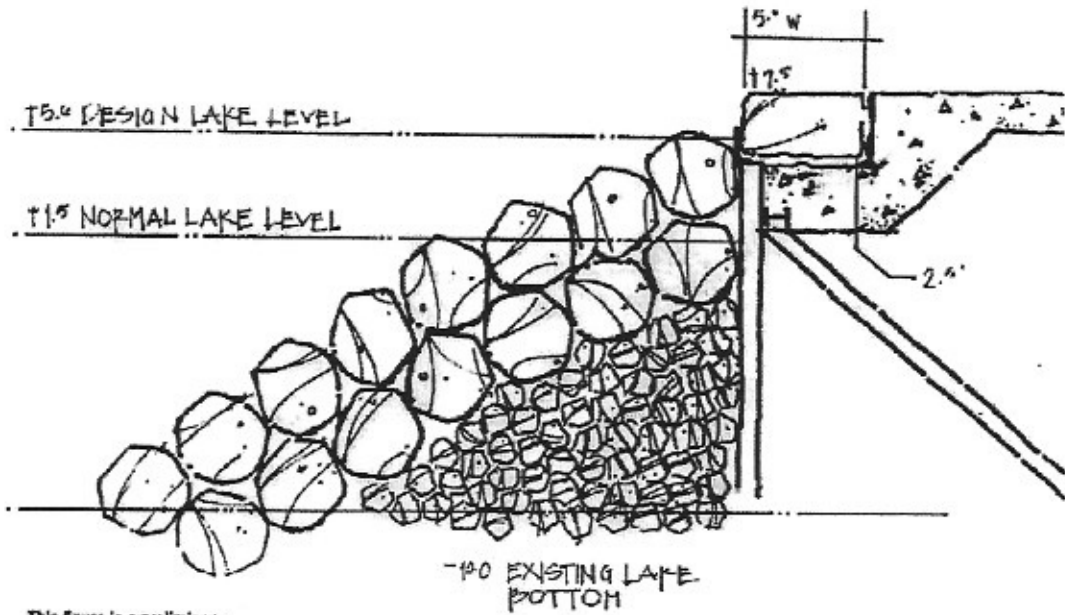
Figure 5

This figure is a preliminary concept sketch prepared for discussion purposes to evaluate relative feasibility.

OPTION #4

The design under review can be loosely characterized as a combination of Option 3 and Option 4—see Figures 4 and 5—in the STS report of January 27 with the following differences:
